A trial of the effectiveness of a permeable rock bund for excluding fish at the Acton intake, Canterbury

Prepared for Irrigation New Zealand

November 2013

NIWA Client Report No:	CHC2013-139
Report date:	November 2013
NIWA Project:	SCJ14502 / 18

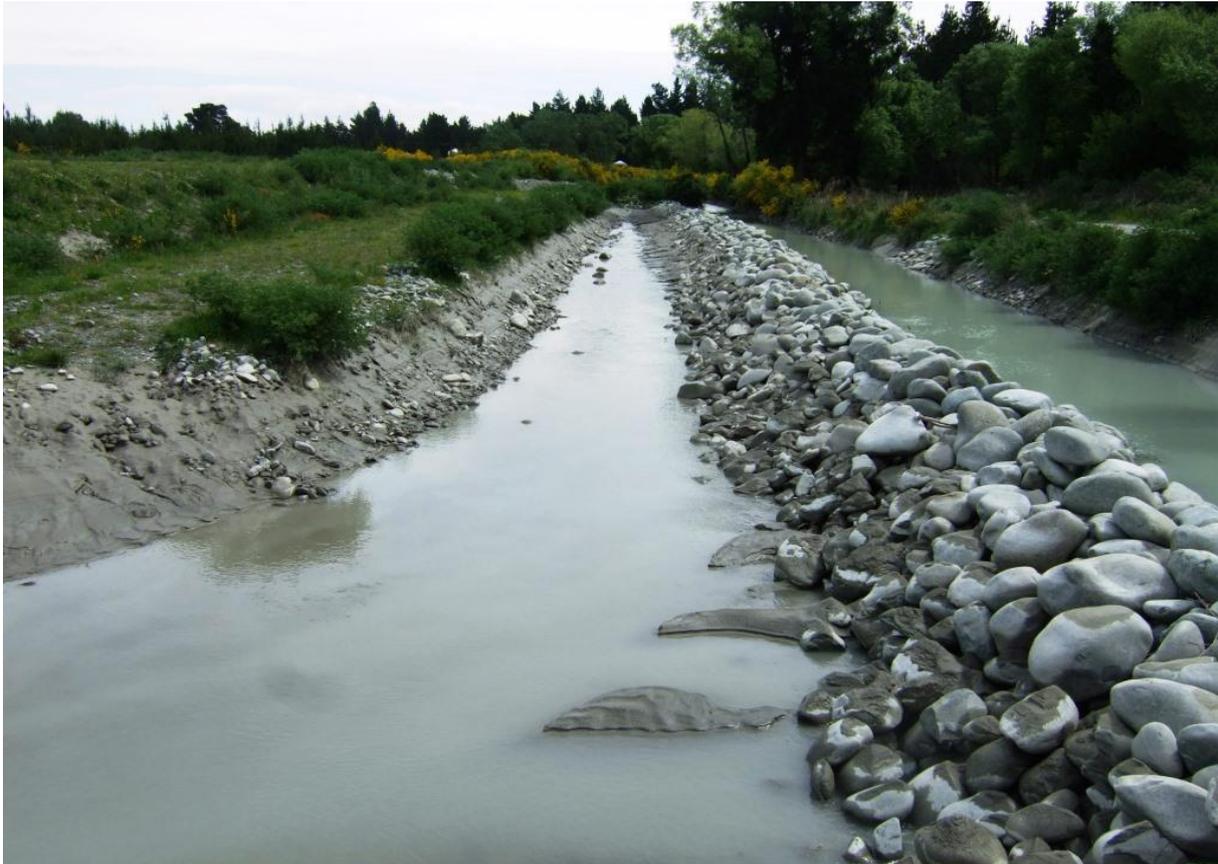
Figure 2-2: The permeable rock bund at the Acton intake, photographed looking upstream and with low water levels. The diversion channel supplying water can be seen the right of the photograph, and the scheme intake channel to the left.

The Acton Irrigation Scheme intake is situated on the southern bank of the Rakaia River, close to the township of Rakaia, c. 1 km downstream of the SH1 Bridge. Water is diverted from an active braid of the river and is passed along a permeable rock-bund; the bund is c.120 m long, c. 3 m wide at the base, and composed of rocks and boulders from c. 100 mm to 500 mm in diameter (Figures 2-1 and 2-2).

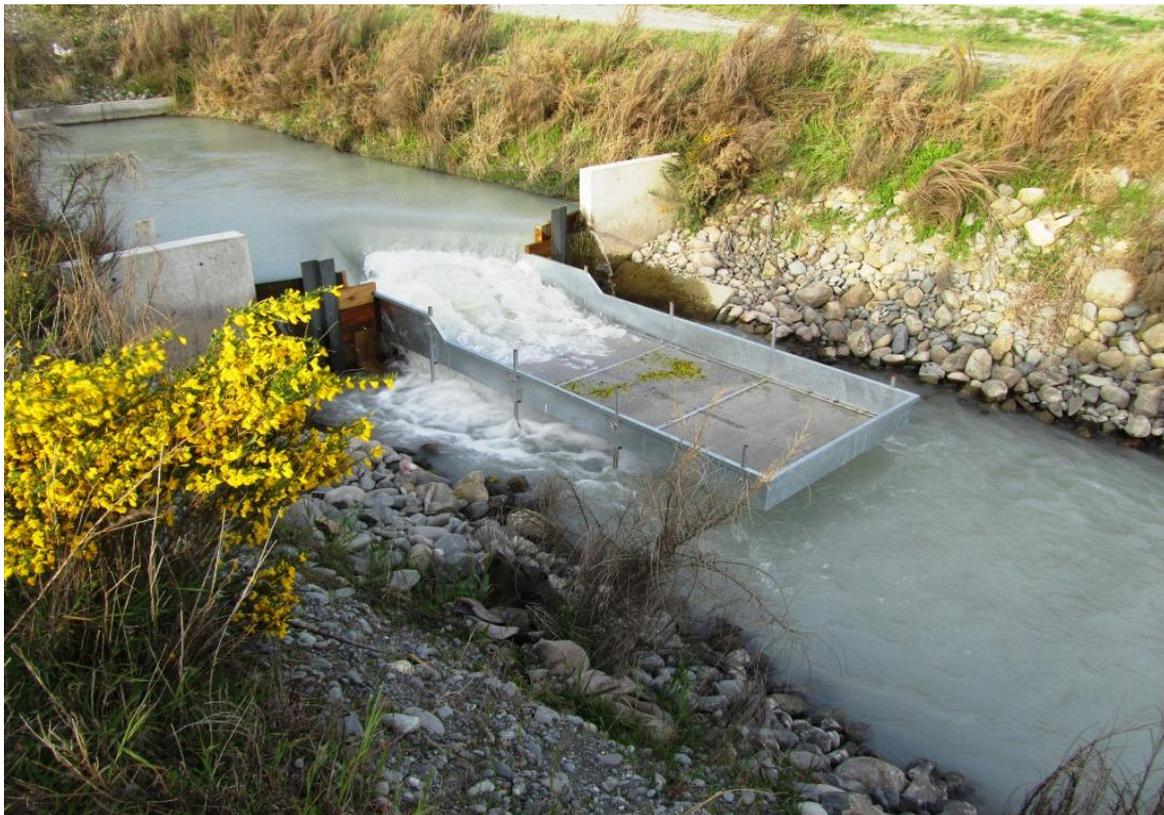
Figure 2-3: The fish trap on the scheme intake channel.

Fish traps were installed on the intake channel and bypass channel (Figures 2-3 and 2-4 respectively) during the afternoon of 21 October 2013. The traps were not able to cope with the full volume of water in the channels, so for this trial the facility was operated at a lesser flow than normal, but with the same bypass: scheme ratio of 1:2.6. The intake and bypass channels were gauged immediately after the fish trial.

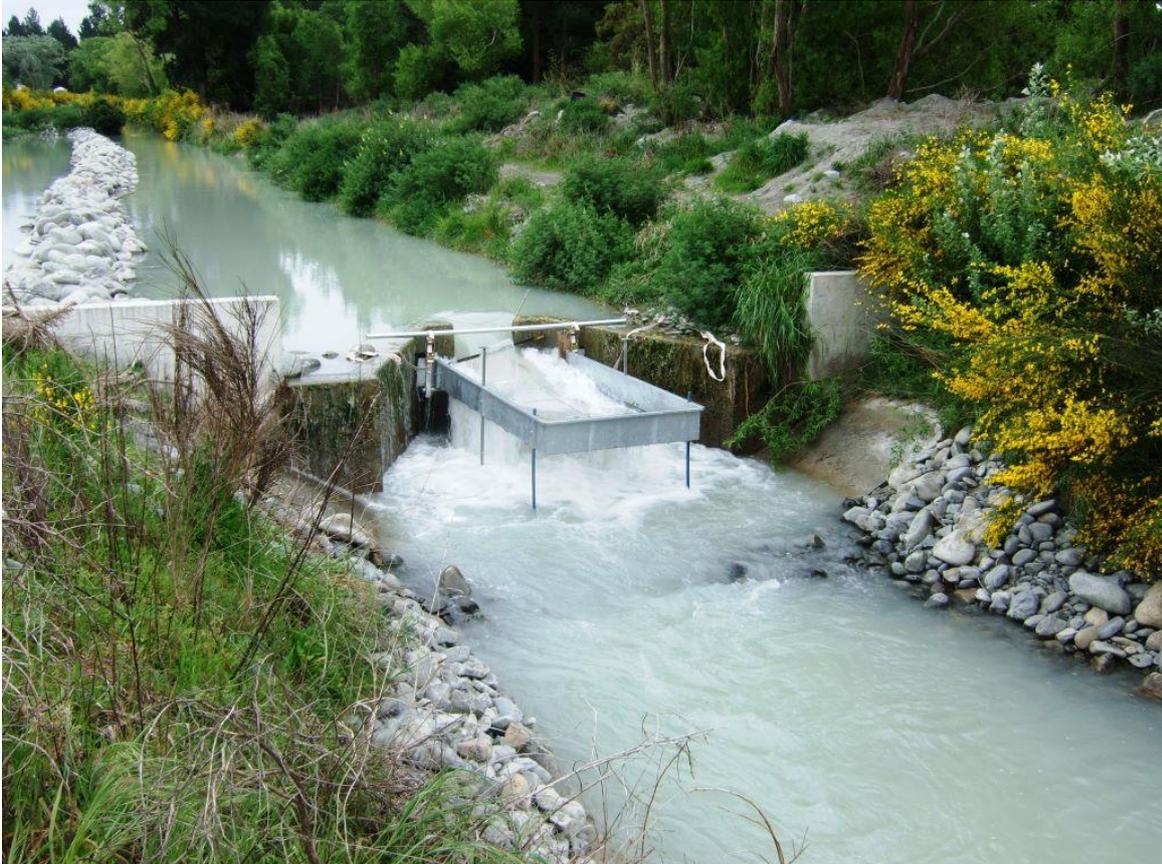
Figure 2-4: The fish trap on the bypass channel. The permeable rock bund can be seen in the background, and upstream of the trap.

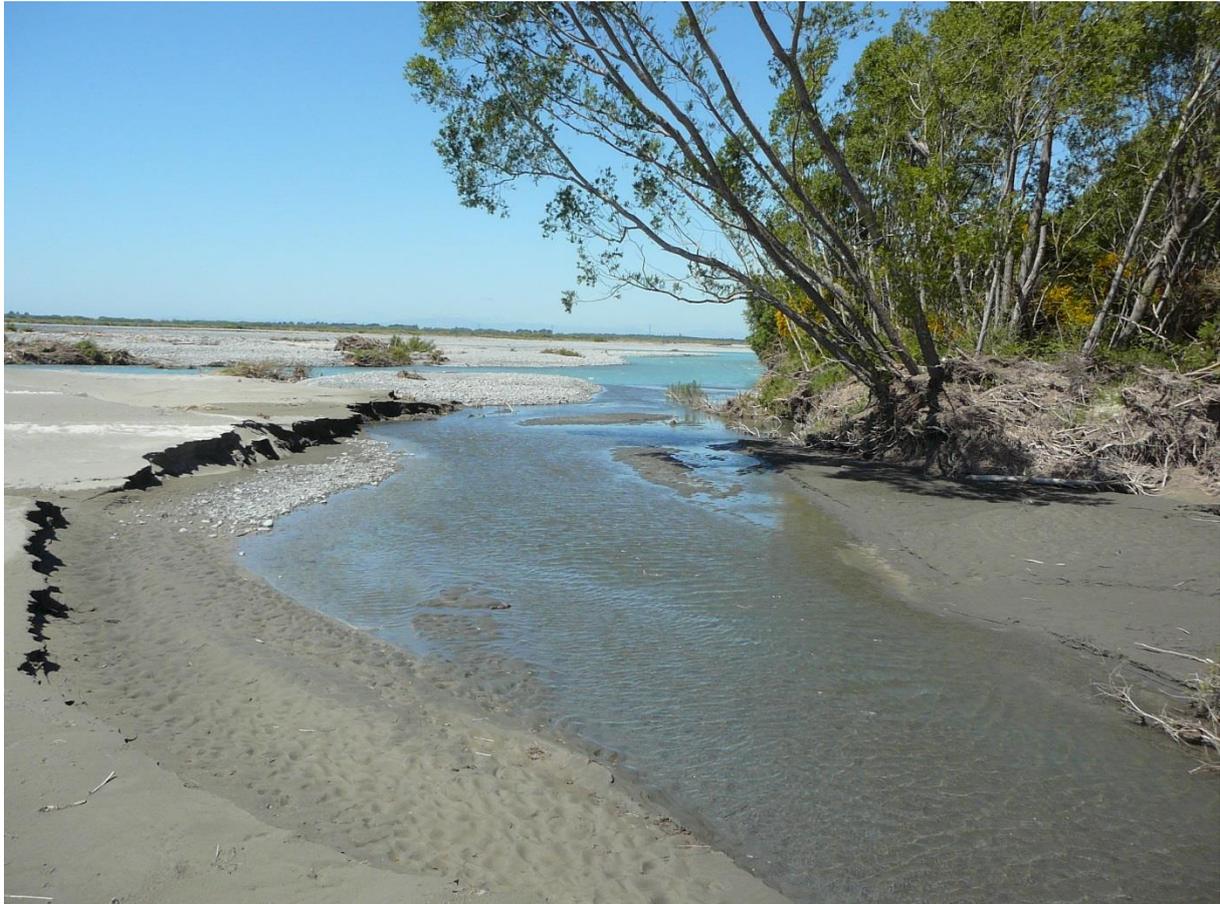
Figure 4-1: Bypass channel returning water to a braid of the Rakaia River, c. 1.4 km from the Acton intake. Note that the flow in the channel here is greatly reduced from the $1.0 \text{ m}^3\text{sec}^{-1}$ bypass flow requirement.

A survey of the bypass channel, to its return into a side-braid of the Rakaia River, was conducted by Hamish Stevens of central South Island Fish & Game shortly after the trials were concluded. Although there was substantial flow in the bypass return channel near the intake facility, it was greatly reduced by the time it had travelled 1.4 km to the main River (Figure 4-1). There are concerns that if the Rakaia River changes course then there is a risk that the bypass return channel may be substantially lengthened, and subsequently become a “dead end” for fish. Ideally the bypass return channel should be as short as possible to prevent this.

2. Ensuring the bypass/return channel is well connected to the Rakaia River at all times is probably the most important factor for excluding fish at the facility – the bypass channel needs to be maintained to provide quick passage back to the river for all fish, and thereby minimise the risks from predation, desiccation and changes in water quality in the channel.
