Levels Plain irrigation fish screen trial 6-9 December 2010

DOC DM-682985, see also draft full experimental scope - DOC DM-667388

Compiled by Nicholas Dunn

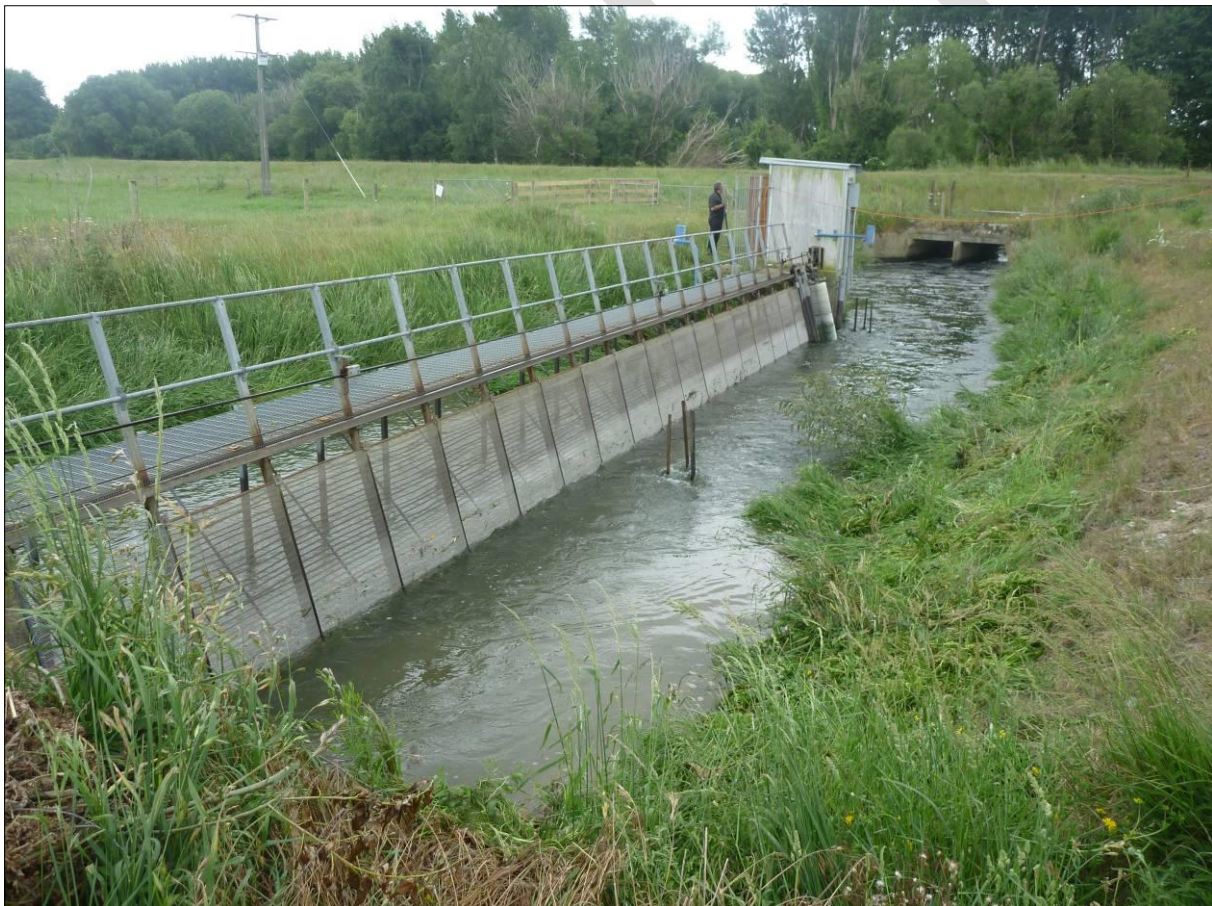
Figure 1. The Levels Plain irrigation screen on 7 December 2010. The DIDSON is positioned halfway along the length of the screen, supported by warratahs. The upstream control gate is positioned upstream of the bridge. Photo by Sjaan Bowie.

The investigation was undertaken at the Levels Plain irrigation intake fish screen (Topo50 BZ19 Timaru E1453239 N5097713), accessed from Butlers Rd, near Pleasant Point. The irrigation scheme is currently managed by Opuha Water. The screen was constructed in 1987 by the then Ministry of Works (Figure 1, 2, and 3). The total length of the fish screen is 16 m, and consists of 18, 0.7 m wide panels of 3 mm mesh. The most downstream end panel has a mesh size of 5 mm. This panel was recently damaged and is now slightly deformed. The original design for the entire screen was for 4.8 mm mesh but this was changed to 3 mm mesh, as the larger mesh was found to be weak and deformable. This suggests that mesh size of screens is determined by engineering constraints rather than consenting requirements.

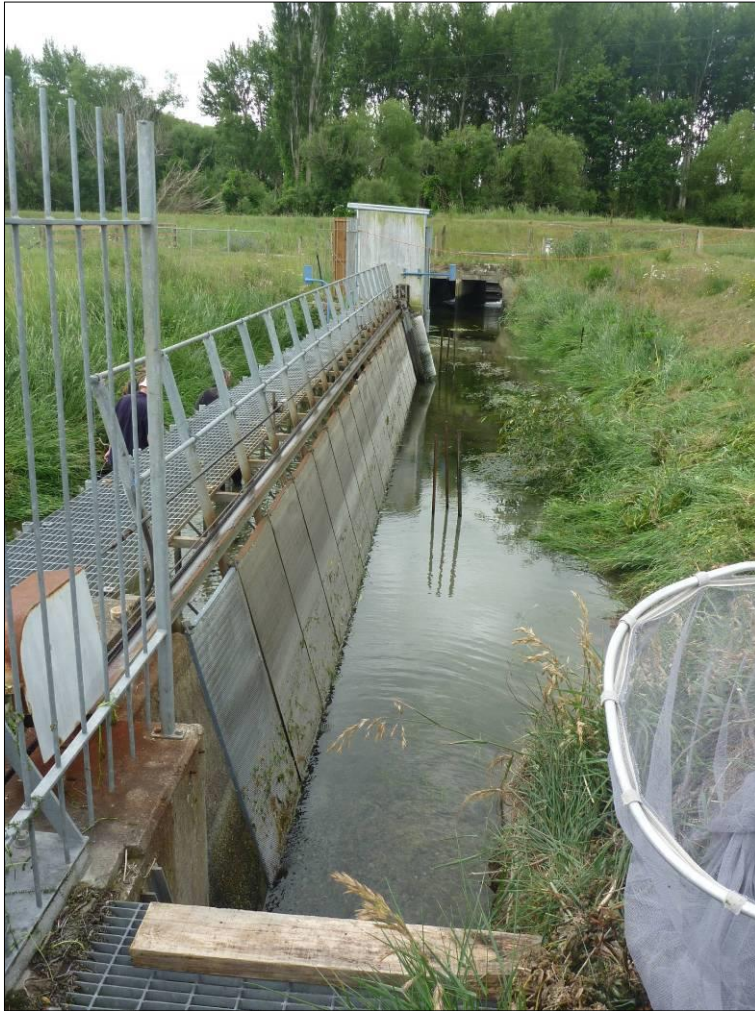
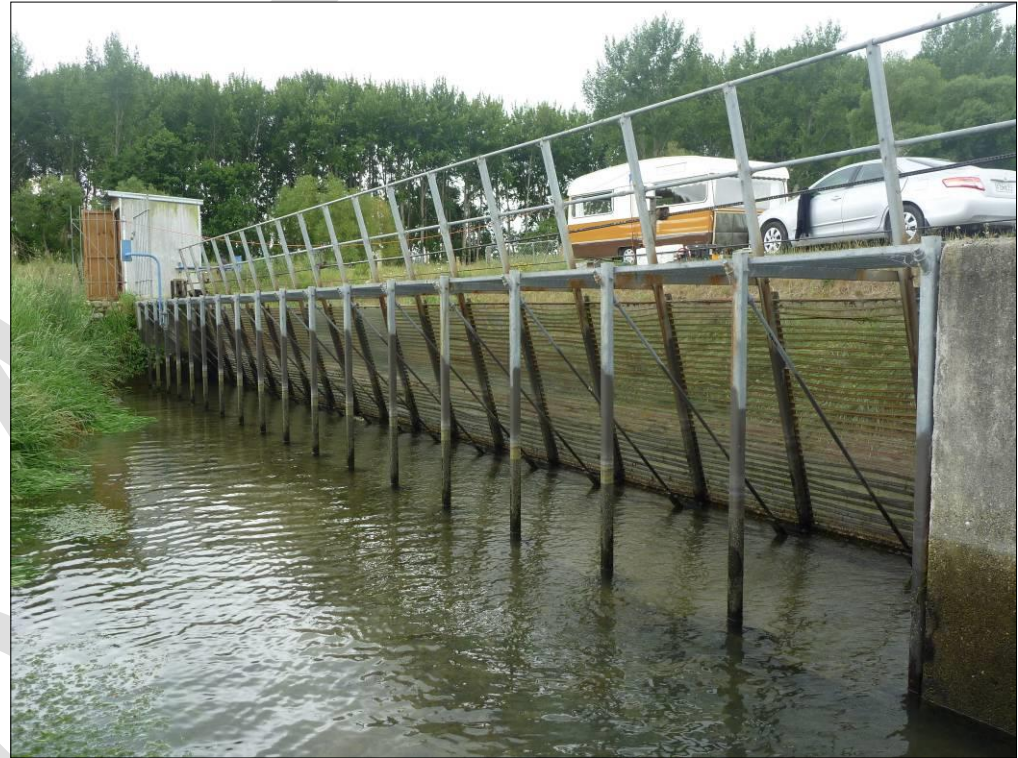
Figure 2. The dewatered forebay and screen, looking upstream toward the bridge and the control gate (left), and the downstream side of the screen while water was shut off. (right). Both photos were taken on 7 December 2010. Left photo by Sjaan Bowie, right photo by Nicholas Dunn.
