A trial of infiltration gallery effectiveness for excluding
fish at the Selwyn District Council intake, Te Pirita,
Canterbury

Prepared for Irrigation NZ

June 2013

NIWA Client Report No: CHC2013-048
Report date: June 2013
NIWA Project: INZ13501

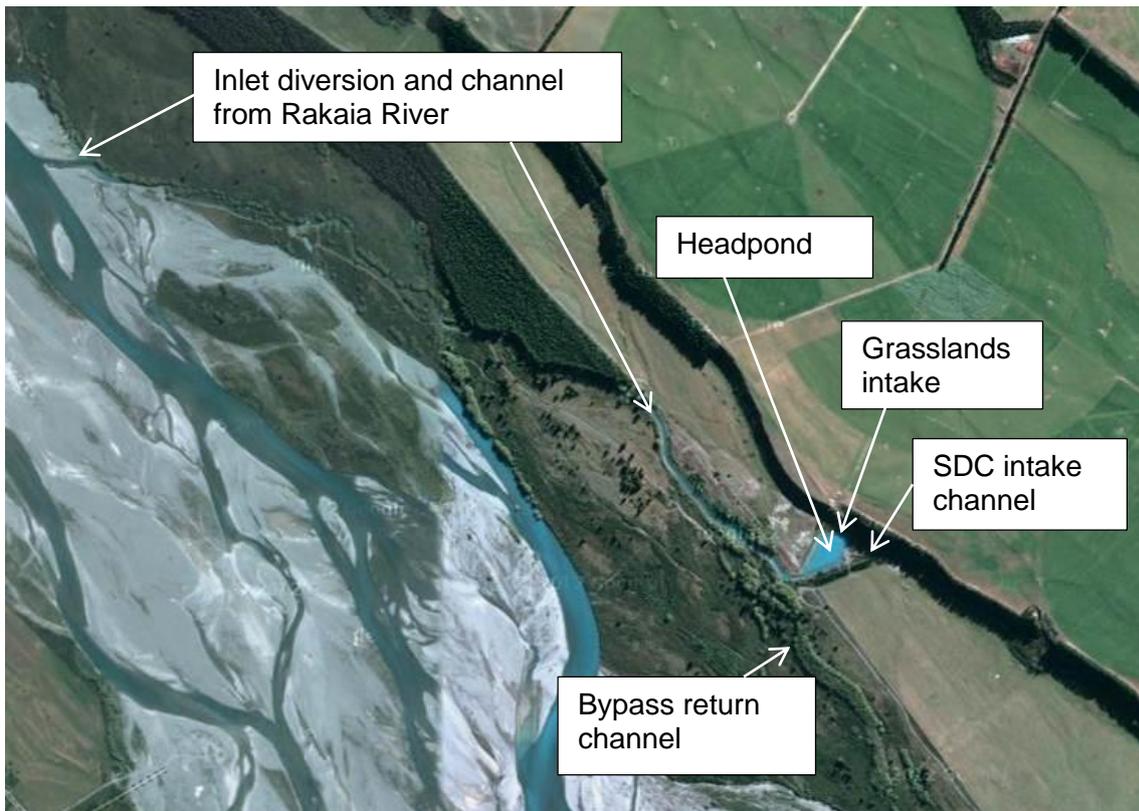
Figure 2-1: Photograph of the SDC intake near Te Pirita (Google Earth).

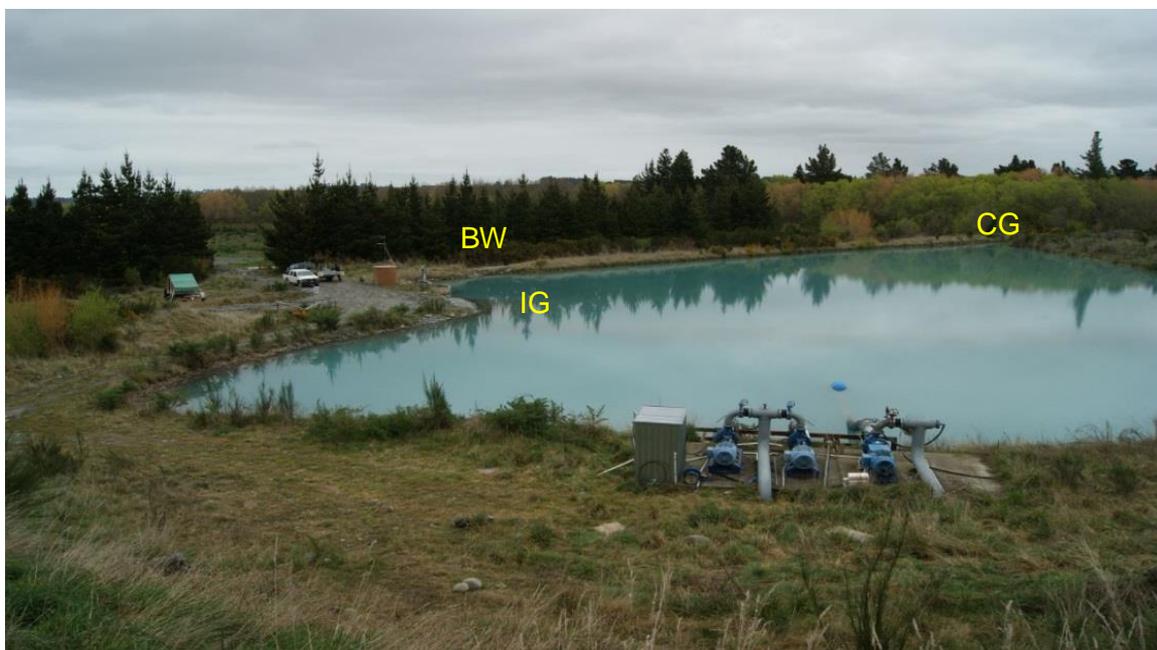
Figure 2-2: The headpond. The infiltration galleries (IG) and SDC intake are situated near the vehicle seen on the left, and the bypass weir (BW) is just visible on the edge of the pond to the right of the vehicle. In the foreground are the pumps for the Grasslands intake (not operating during this trial), and on the far right of the headpond is the control gate (CG) for water entering from the Rakaia River via the inlet channel.

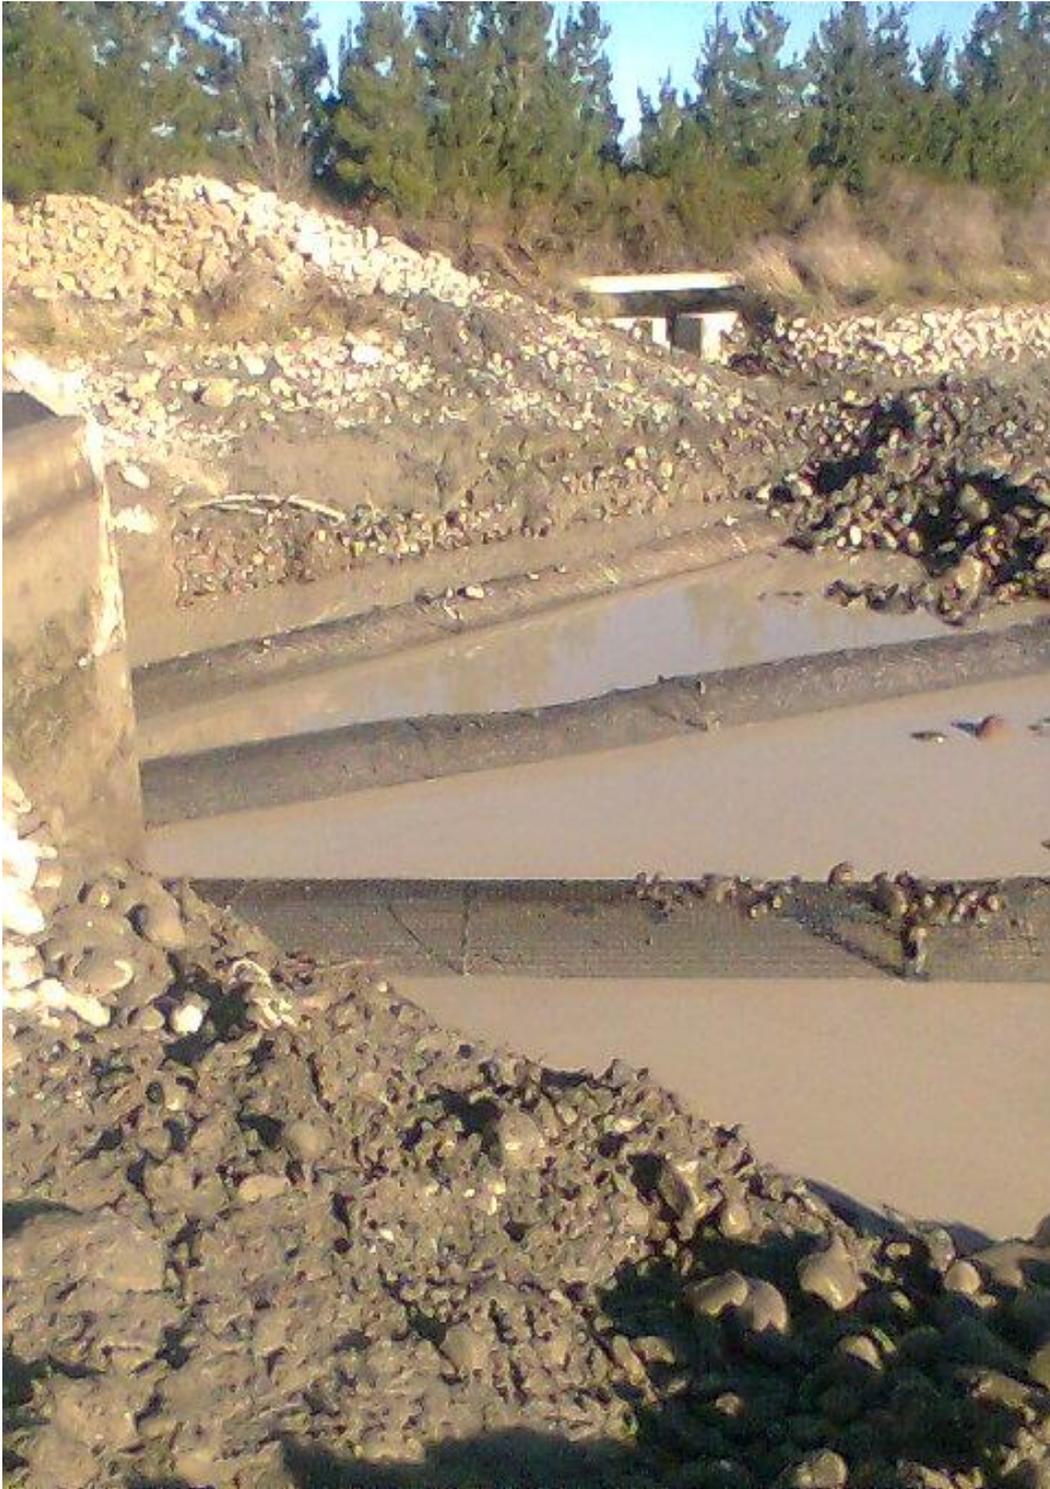
Figure 2-3: The infiltration gallery pipes, Winter 2012. Screen material and silt had been removed during maintenance and new material was replaced before the headpond was refilled.

The facility appeared to be generally well operated and maintained, and the substrate over the gallery pipes had been removed and replaced during the preceding winter. Replacing the substrate from time-to-time counteracts the build-up of fine silts which otherwise clog up the substrates above the gallery pipes and impede the flow of water through the structure; rather than clean the substrates *in situ*, it is more practical to simply remove all the existing substrates and silt, and replace them with new (silt-free) gravel and boulders. This maintenance not only has the benefit of allowing the full flow of water through the gallery, but may also promote a more uniform distribution of flow above the whole gallery. The potential drawback of such maintenance is that it might be poorly done; for instance, if the layer of substrate is replaced by one of lesser depth and/or larger boulders, it is likely to cause some areas of high approach velocities that fish could not resist.

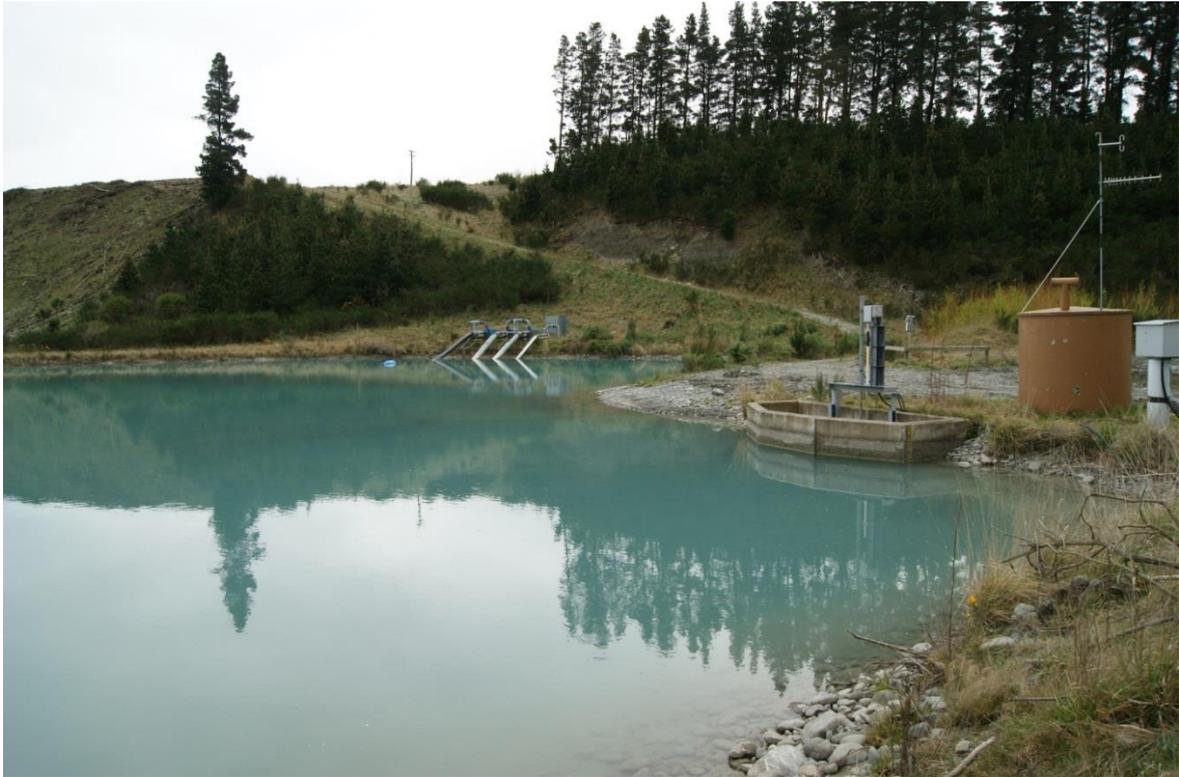
Figure 2-4: The headpond as seen from near the bypass weir. In the foreground the SDC intake control (brown cylinder) and headworks for the infiltration galleries (bunded structure). The galleries are underwater and under a layer of gravel and boulders in the centre foreground of the picture.

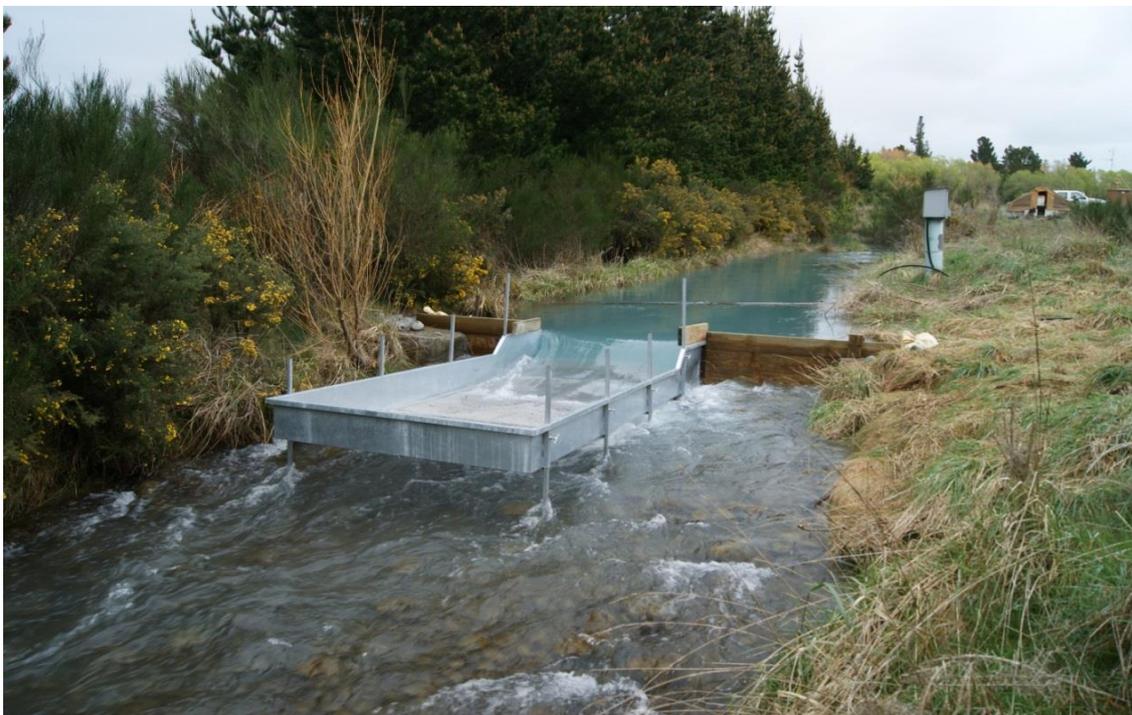
Figure 2-5: The intake trap. Water passing through the infiltration gallery flowed into the scheme intake channel and then through the trap.

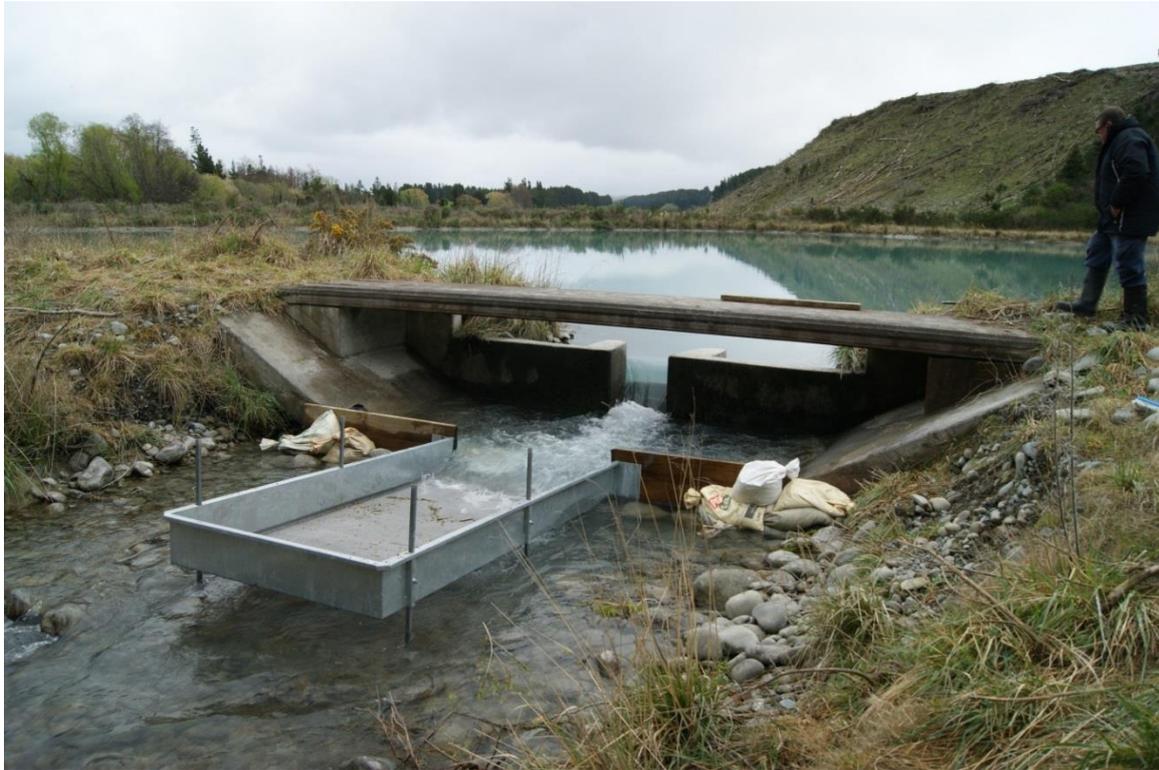
Figure 2-6: The bypass trap. This trap was installed directly in the bypass channel immediately downstream of the outlet weir.

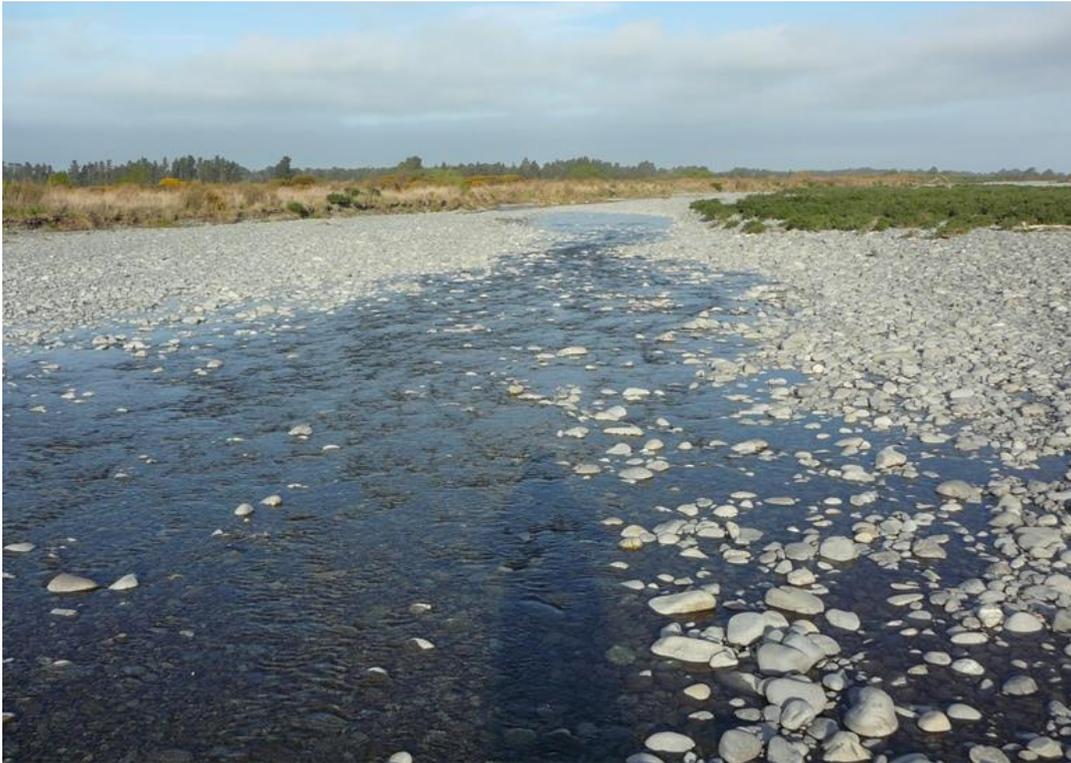
contained many reaches with shallow water and little cover, which would expose fish to increased risk of predation (Figures 4-2 and 4-3). There is also probably a risk of losing connection with the Rakaia River if flows in the bypass channel were lower than during the trials.

Figure 4-2: The bypass return channel about 1 km downstream of the headpond. Here the channel is wide, shallow and lacking cover for fish.

Improvement of the bypass return channel could be achieved relatively simply by shortening the channel as much as possible and directing it out towards the Rakaia River channels, rather than let it meander downstream for 5 km.

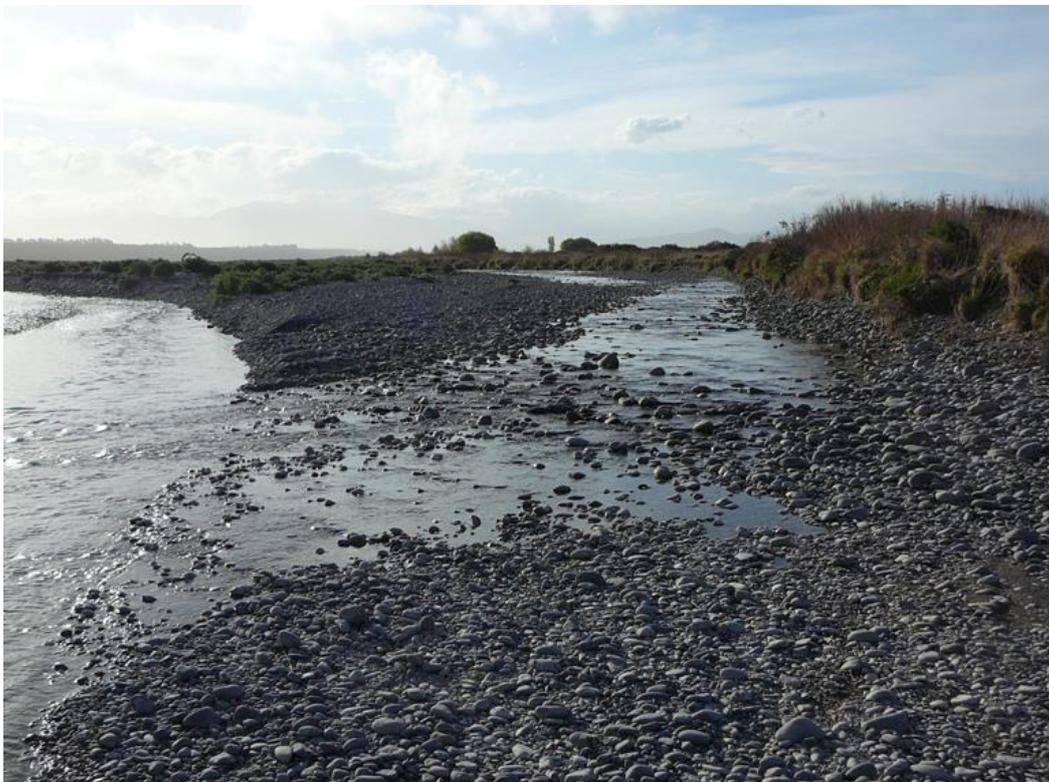
Figure 4-3: The bypass return channel (on right) joins a braid of the Rakaia River.
